Highlights of Sandia's Photovoltaics Program

Sandia
National
Laboratories

In this issue, module durability research at Sandia is discussed.

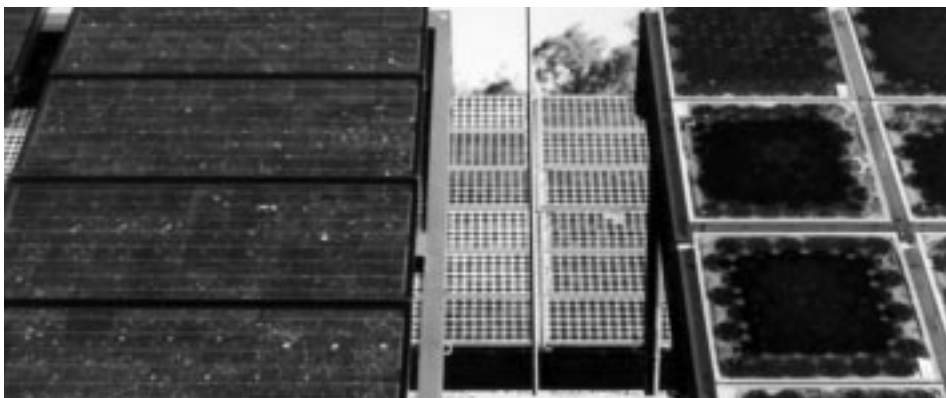
Figure 1. New and 20-year-old module technologies in arrays at Natural Bridges National Monument, Utah.

As a result of the relatively slow evolution of photovoltaic technology, an additional opportunity now exists for more rapidly improving the lifetime of modules. A large number of qualified modules from established manufacturing facilities have now been in the field for many years, in some cases approaching 20. Detailed investigation of these field-aged modules has resulted in new techniques to identify degradation mechanisms and has provided insight required to optimize manufacturing processes for extended module lifetime. For example, a field survey and subsequent module autopsy were recently conducted on a system installed in Utah in 1979 with modules from four different manufacturers (Figure 1). These modules provided durability information after nearly

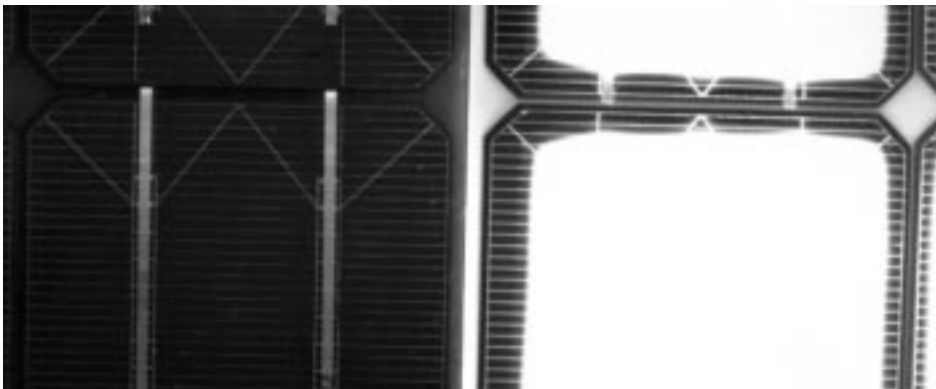
Figure 7. EVA browning patterns highlighted by illumination with 375-nm lamp. Damaged EVA fluoresces producing rectangular regions shown on cells in 1984-vintage module at right. Unexposed cells at left.

For almost 15 years, the dominant encapsulant material in the photovoltaic industry has been EVA. As a result, a significant level of research by industry and by NREL has been aimed at understanding and improving the properties of EVA for application in photovoltaic modules. Particular emphasis has been given to minimizing the propensity of EVA to discolor or "brown" after long-term exposure to ultraviolet sunlight with module operating temperatures often above 50°C. Commercial EVA sheet material, available from STR Corporation, comes in two generic types: "standard cure" (A9918) and "fast cure" (15295), with the fast-cure material having somewhat better UV aging characteristics. A convenient way for highlighting EVA damage is to illuminate the module with a 375-nm hand-held UV lamp. If the EVA has degraded, it will fluoresce over a wide wavelength range looking "white" (Figure 7). Samples of standard-cure EVA have been extracted from field-aged modules in order to measure the optical loss in transmittance (see Figure 8). For modules of this vintage, EVA browning often resulted in module power degradation rates on the order of 1% per year.

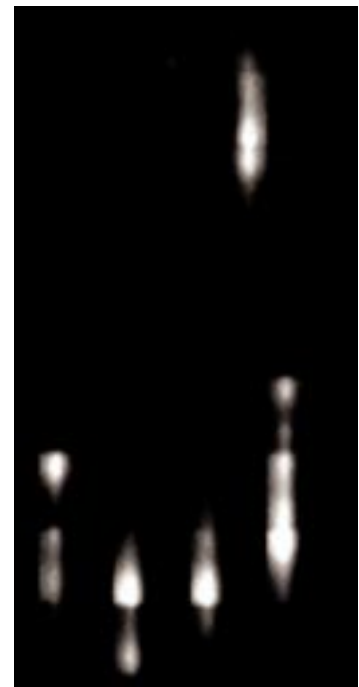
Figure 15. Thermal infrared image of 36-cell module with abnormally resistive solder bonds.

Thermal infrared imaging has provided a convenient and non-destructive means for identifying locations in modules where the series resistance was atypically high. The procedure involves connecting a module to a power supply with the module in a forward-biased condition electrically. The power supply provides a continuous current through the module at a level between one and three times the nameplate short-circuit current. As the module heats up, a digitized image can be recorded showing the temperature distribution in the module. Using this procedure, resistive solder bonds in field-aged modules can be identified as localized hot spots in the image. Figure 15 shows a module with abnormally resistive solder bonds after about six years in the field.
